# DATASHEET

DAPU P/N : 011F-Q311-20.00MHz-A

## Guangdong Dapu Telecom Technology Co.,Ltd

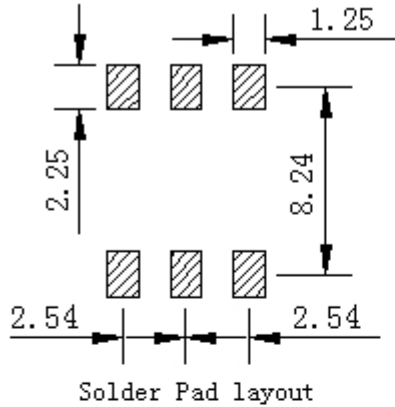
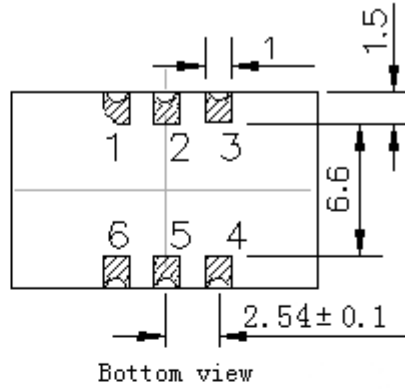
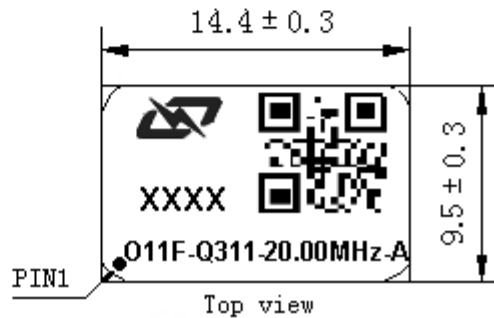
## 2. Mechanical Structure (mm)

PIN	NOTATION	FUNCTION
1	VC	Control Voltage
2,5	NC	Not Connect
3	GND	GND
4	OUTPUT	RF Output
6	VCC	Supply Voltage

- Note1:** Tolerance  $\pm 0.2$ mm without mark
- Note2:** The first two xx representative: week  
After two xx representative: year
- Note3:** Referential weight 2.2g
- Note4:** NC is not connect
